UNDERWATER BRIDGE INSPECTION REPORT

STRUCTURE NO. 6676

RED RIVER OF THE NORTH

MINNESOTA DEPARTMENT OF TRANSPORTATION
UNDERWATER BRIDGE INSPECTION

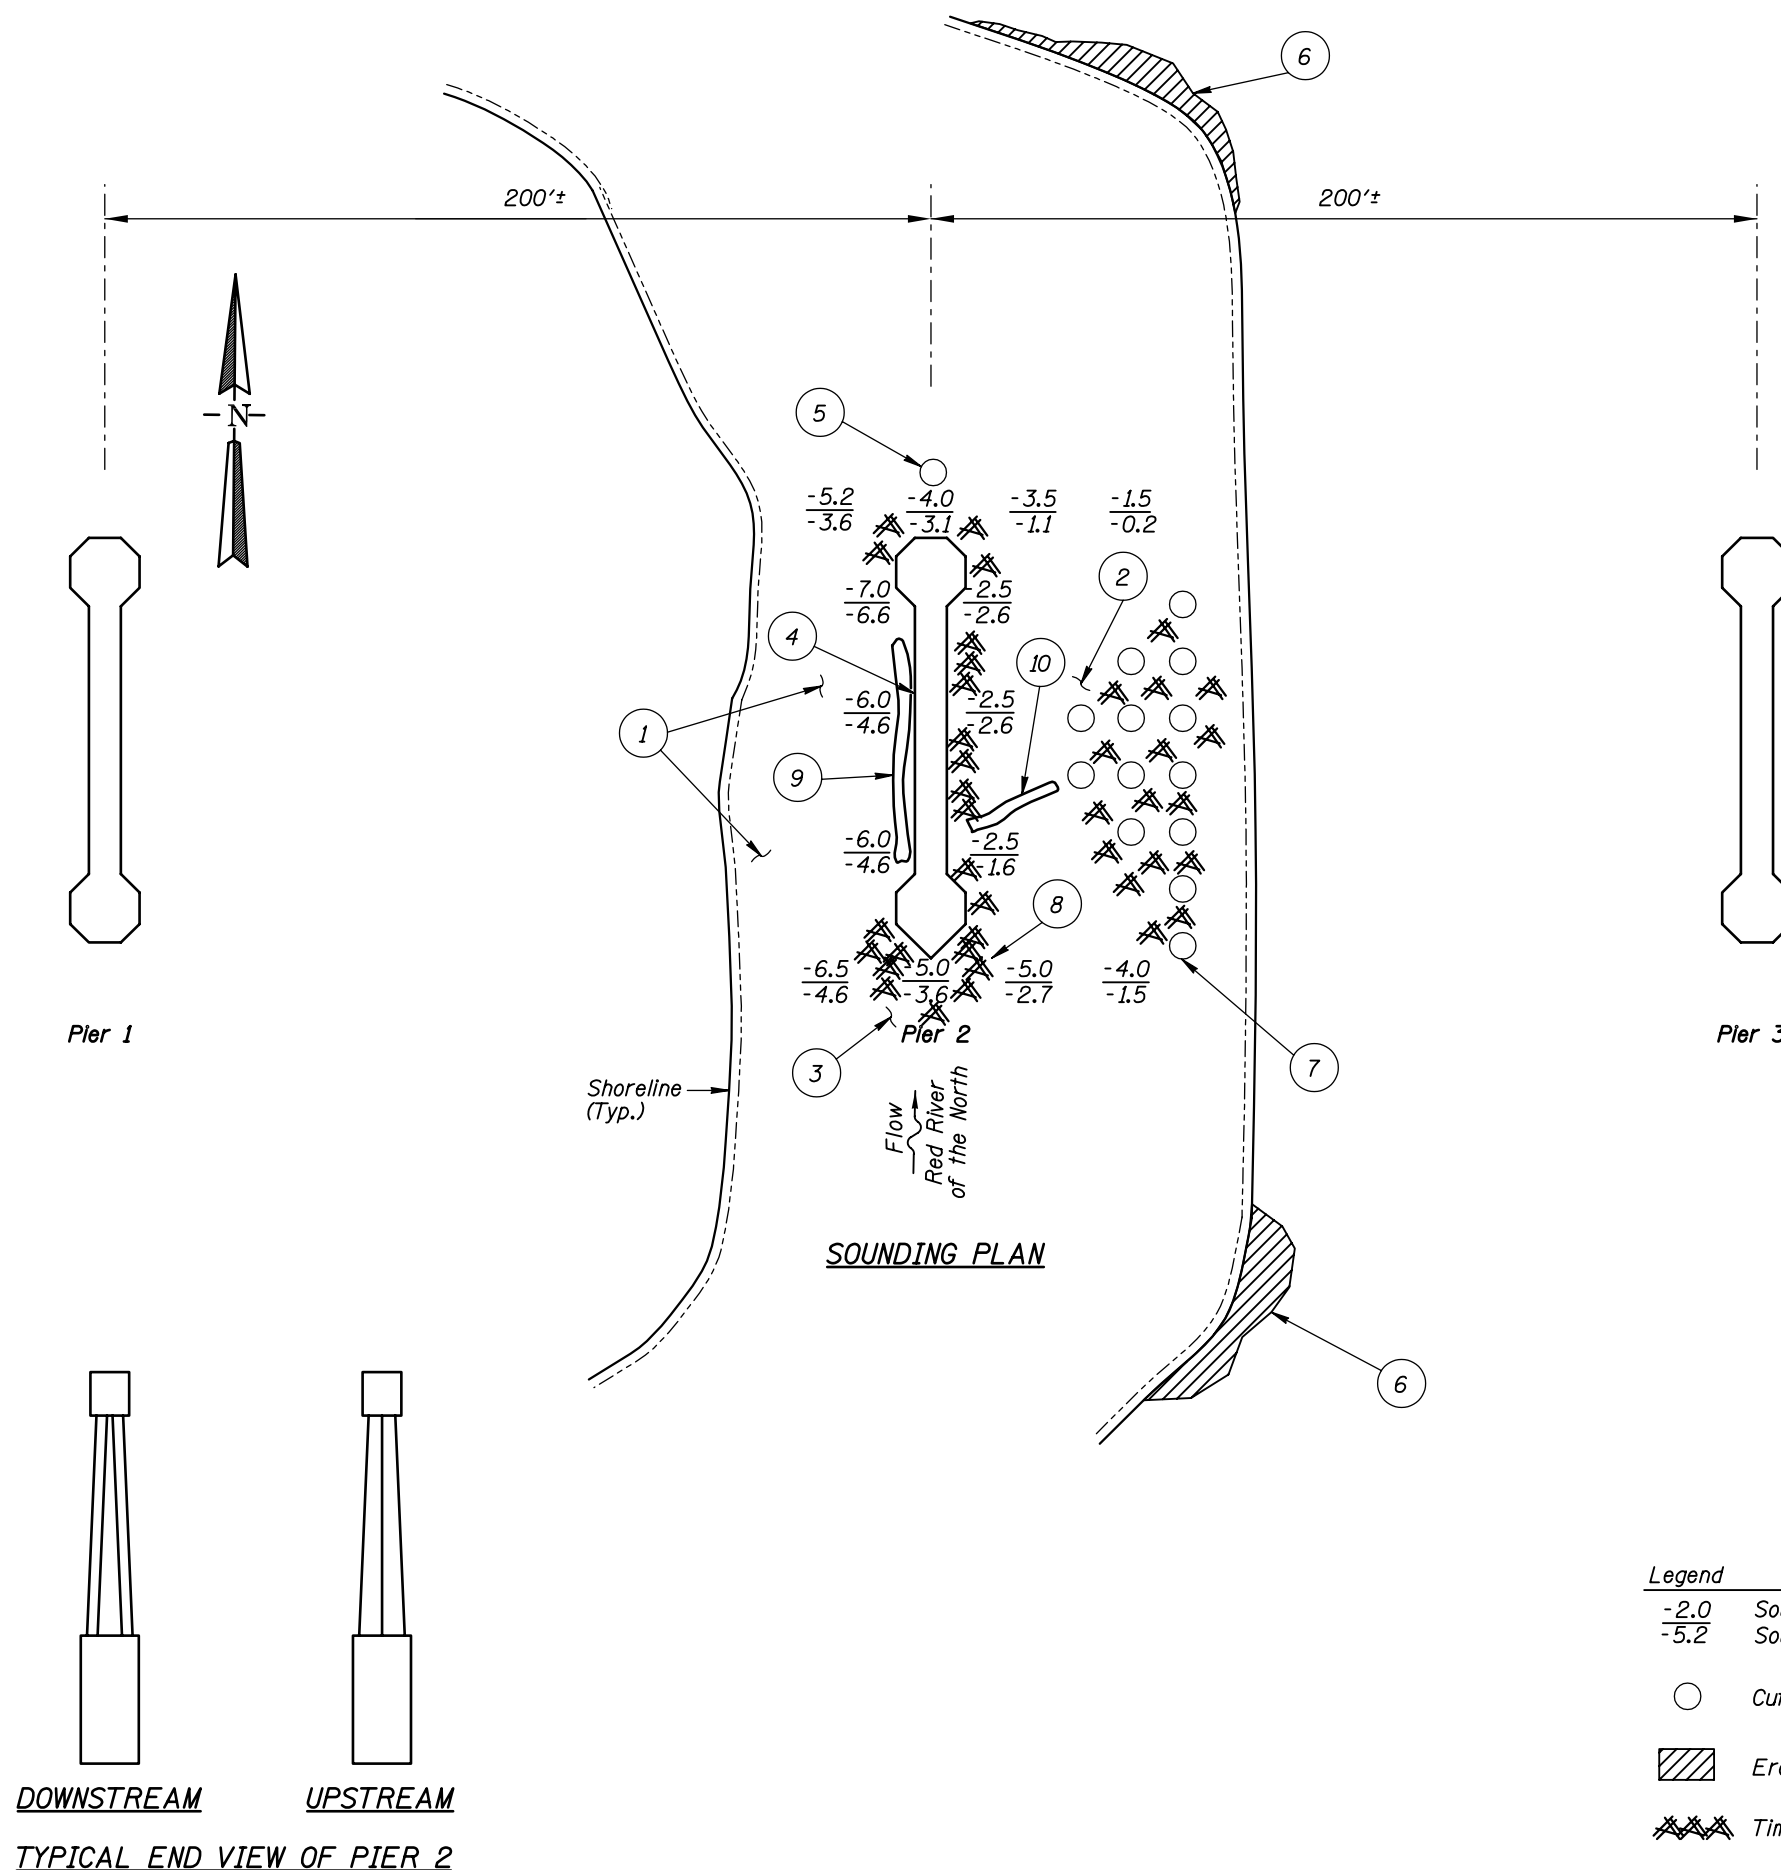
INSPECTION AND SOUNDING PLAN

- The channel bottom material at the upstream nose of the pier consisted of hard clay with 2 to 4 inches of maximum probe rod penetration.
- The concrete surfaces of the pier were sound and in good condition with no significant defects observed.

- An abandoned timber pile was observed 2 feet north of the downstream nose of Pier 2, extending from 1 foot below the waterline into the channel bottom.

- Heavy bank erosion was located along the eastern shoreline, upstream and downstream of the bridge, exhibiting 10 foot vertical banks, loss of soil, and exposed tree roots.

- Abandoned timber piles cut off approximately 3 feet above the waterline with scattered accumulated timber drift, with pieces up to 1 foot in diameter, throughout.

- Timber debris consisting of 8 to 10 inch diameter branches was observed at the upstream nose of the pier, along the entire east face of the pier shaft, and around the downstream nose, extending from the channel bottom up to the waterline.

- A log, 1.5 feet in diameter, extended along the west face of the pier shaft on the channel bottom.
- A 2 foot diameter log was observed extending out of the channel bottom to 2 feet above the waterline on the upstream east side of the pier shaft.

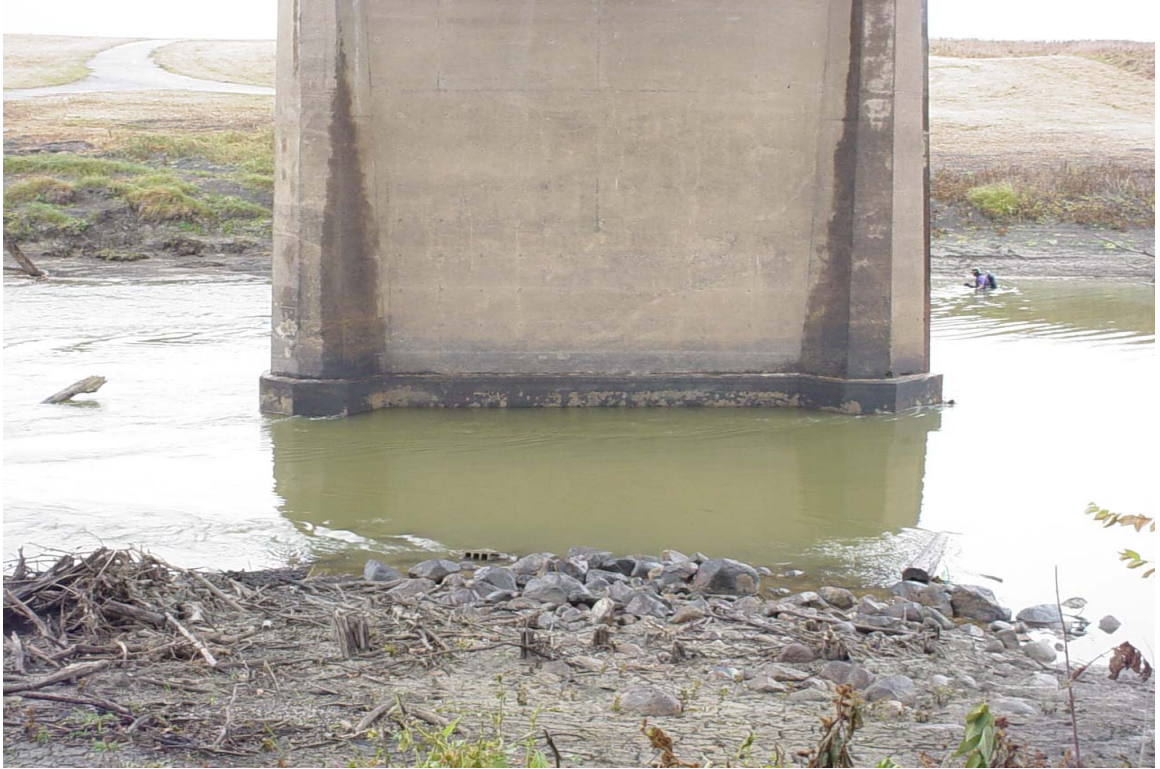
Photograph 3. Overall View of Pier 2, Looking East.

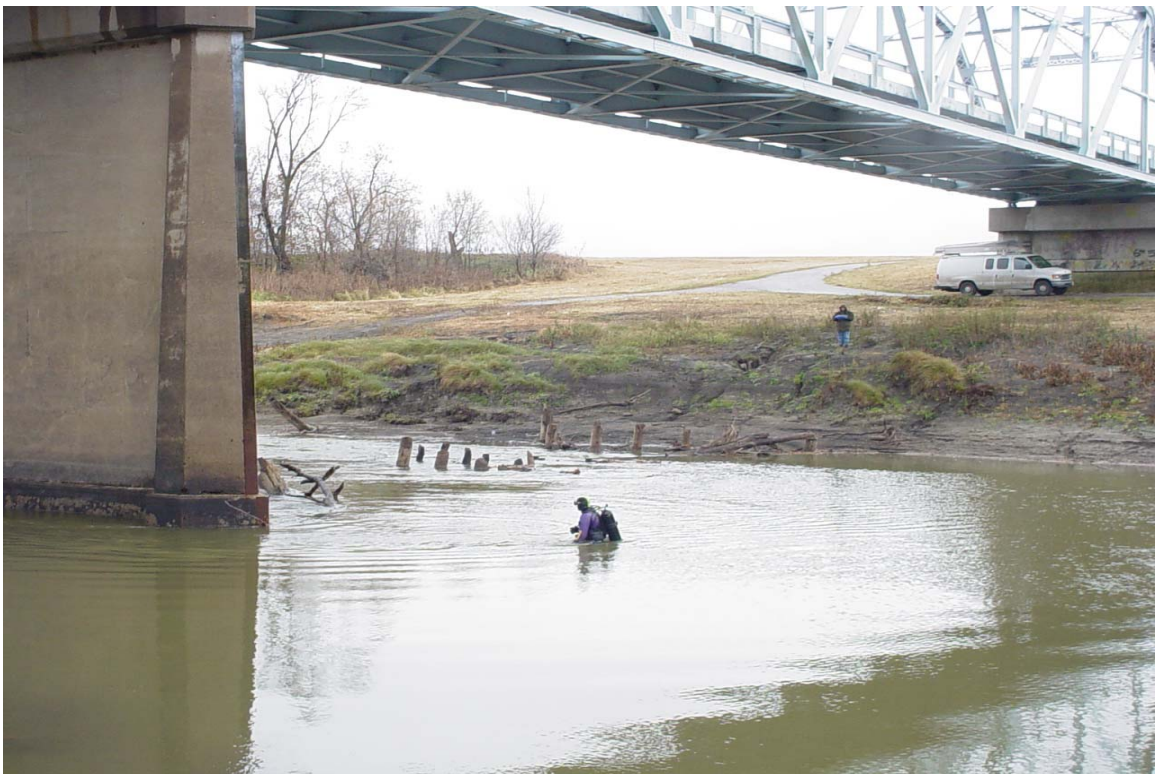
Photograph 4. Overall View of the East Bank, Looking Northeast.

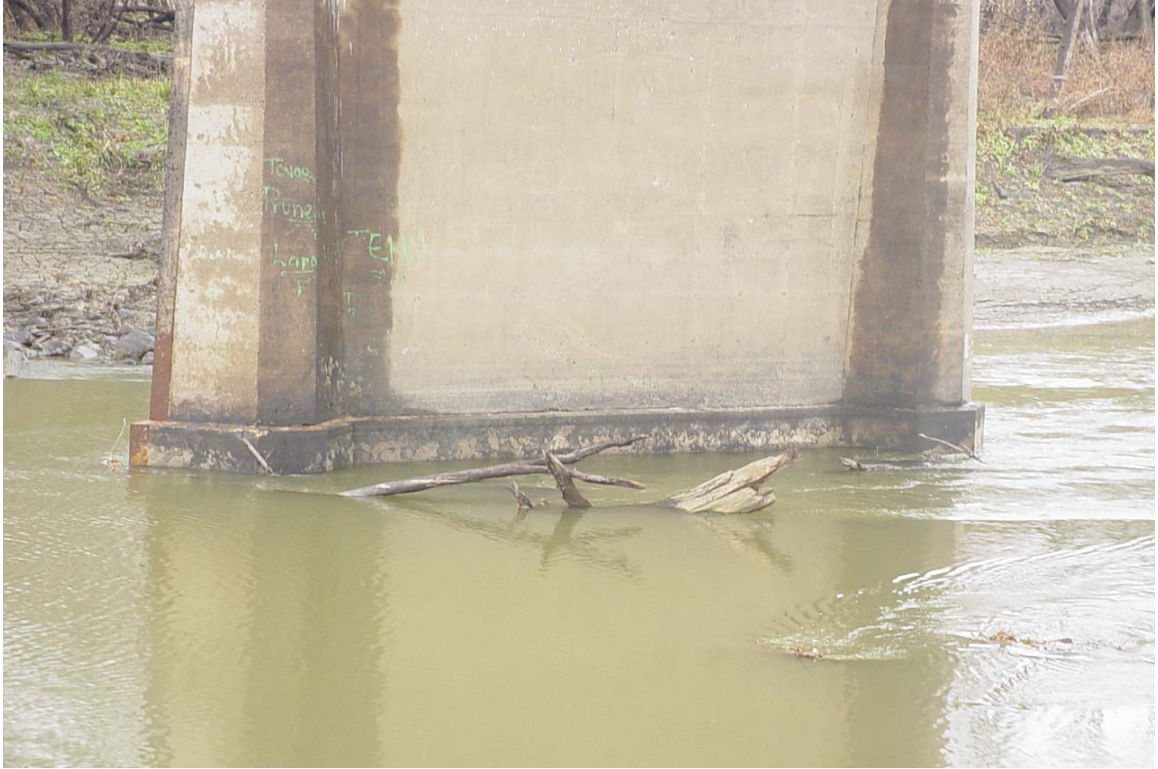
Photograph 5. View of the Timber Debris at the Upstream Nose of Pier 2, Looking West.

- (A) Ideally, the moderate accumulation of timber debris located around Pier 2 and the abandoned timber piles should be removed. In addition, consideration could be given to cutting down the abandoned piles to prevent future accumulations. Until removal operations are accomplished, future inspections should particularly monitor the drift accumulations.

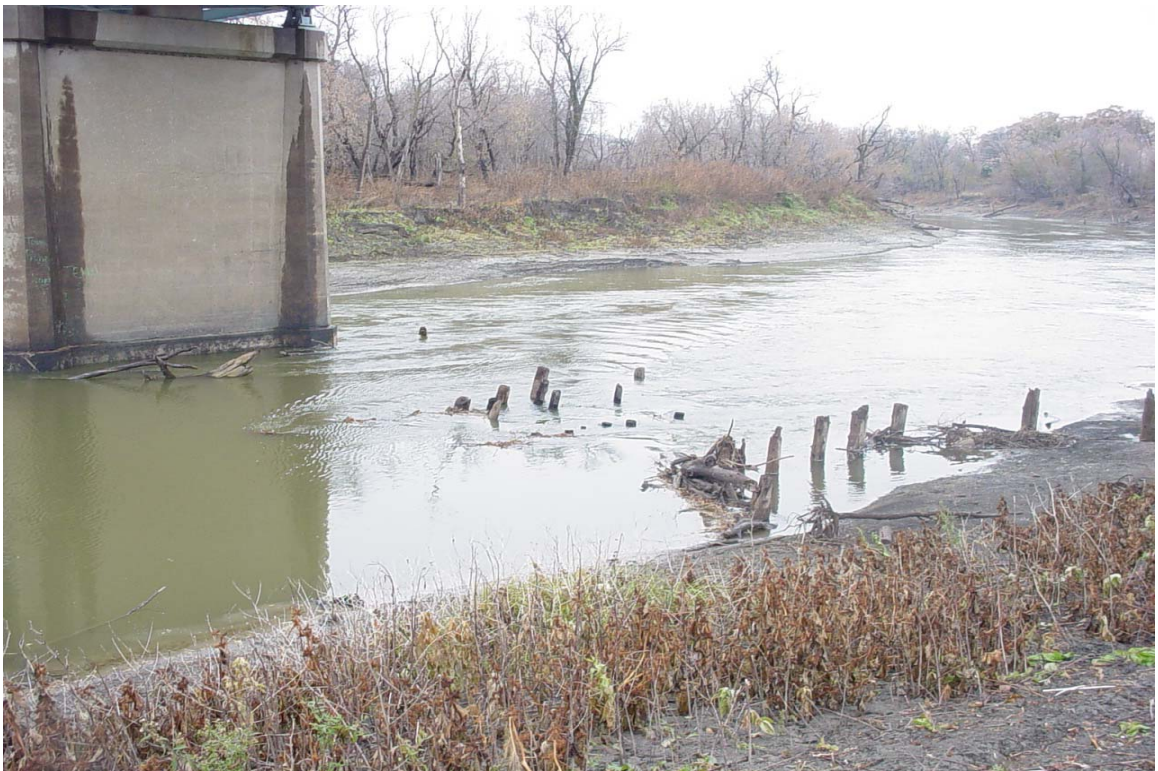
Photograph 6. View of the Abandoned Timber Piles Along the East Bank, Looking Northwest.
